Practical research: dry dust filter cartridges after use in hydrogen and natural gas

A comparative analysis of the effect of hydrogen versus natural gas on filter cartridges

Stephanie van Ooijen

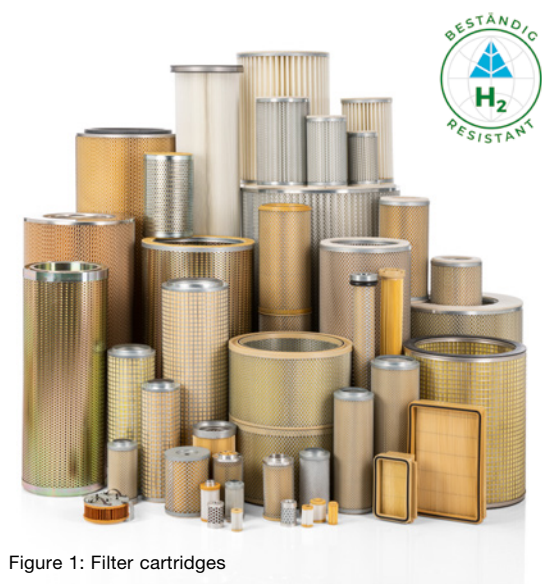
Figure 1: Filter cartridges

An investigation was conducted to provide concrete evidence of this. For this purpose, three VoTech filter cartridges were made available for testing. Sample 1 is in new condition and has not been used for filtration purposes. Sample 2 was used for one year in 100 % hydrogen gas (60 °C) with heavy tungsten contamination. Sample 3 was used for one year in dry natural gas. Sample 3 differs in construction due to an additional outer support, end caps and steel quality.

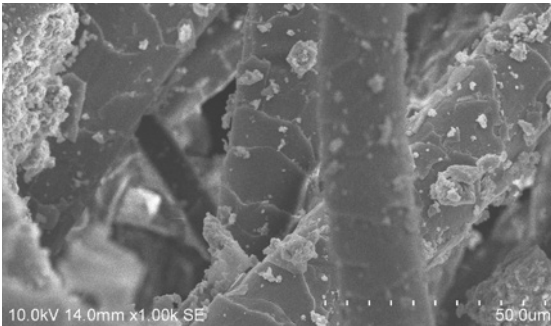
Figure 2: Fibers of the wool felt.

sample 1, is not observed at the examined areas. A higher magnification of the wool felt (Fig. 5) reveals the scaly structure of the individual fibres together with individual particles. Wool is typically characterized by a scaly structure on the surface and can thus be distinguished from for example polyester fibres which have a smooth and homogeneous surface. The particles can be traced back to the use of the filter in the gas flow. There are no damaged fibres or fibre ends observed at the examined areas. It can be concluded that operation in the natural gas flow has caused no damage.
